Characterization of seawater reverse osmosis fouled membranes from large scale commercial desalination plant

Capsule Summary: This study reveals an autopsy study of a fouled seawater reverse osmosis membrane, used for two years in Benisaf Water Company desalination plant in Algeria, to study membrane performance degradation.

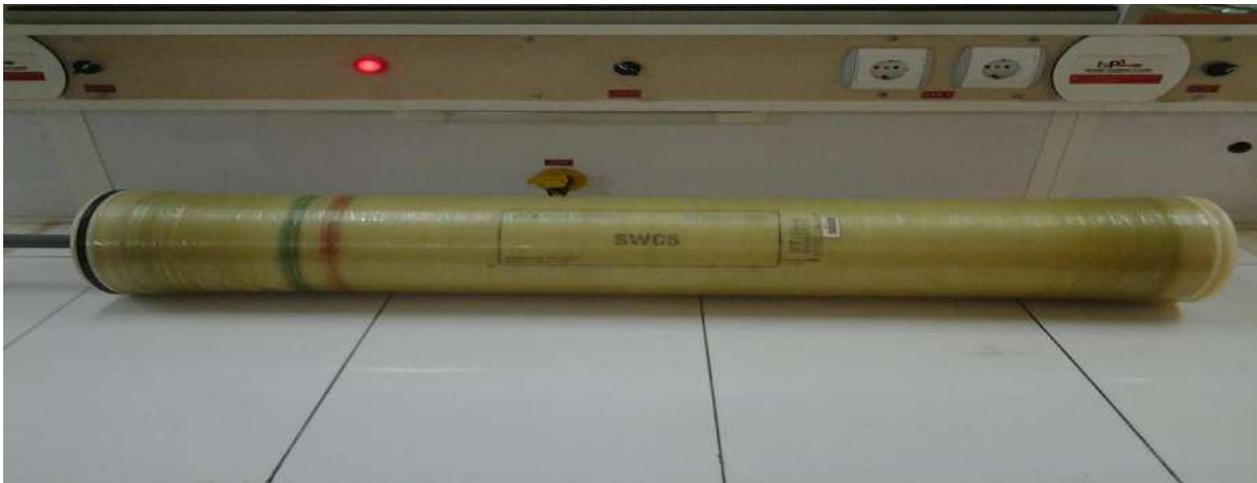
Fig. 2: The fouled RO membrane element

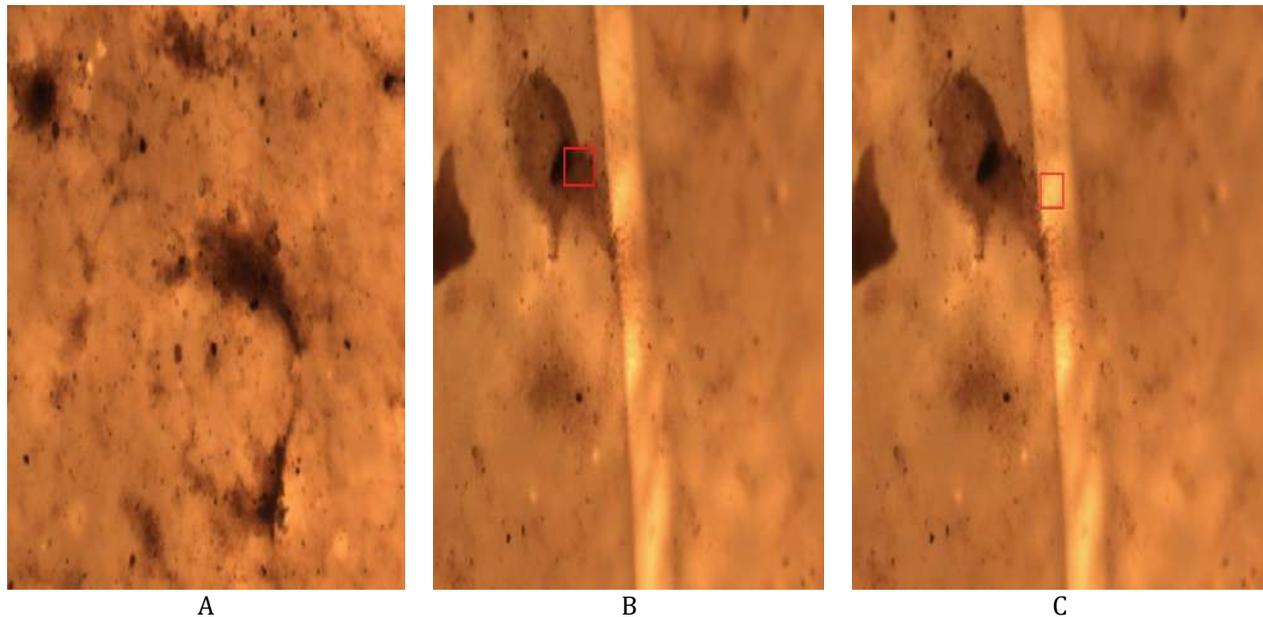
Fig. 3: Optical images of the membrane surface (b) in the vicinity and (c) in site of the feed spacer

Figure 3 shows the optical images of the membrane surface at different locations. Microscopic observation of samples reveals the importance of fouling deposition in the membrane surface. We notice that the distribution of the fouling charge is unequal on the surface with the presence of brown stains. We can also observe that the zone outside the feed spacer (Figs. 3-b) is more charged than the area below it (Figs. 3-c). The fouling particles act as a barrier and prevent the water from diffusing through the membrane which reduces the performance of the operation. The SEM images show the morphological aspect of the fouling as well as the importance of the thickness of the layers (Fig. 4). The deposits were distributed unevenly across the membrane surface. We also notice that the zone outside the feed spacer is more loaded than the other zone as shown in figure 5. Inspection by SEM EDS confirms the diversity of the fouling composition layer across the surface of the membrane and provides a better understanding of the nature and method of layer development. As shown in Figures 5-6, a typical fouled membrane surface consisted of particulate matter embedded in an apparently amorphous matrix (Thuy et al., 2007). Associated EDS analyses indicate that the particulate matter had relatively high levels of C, O, Al and Si.

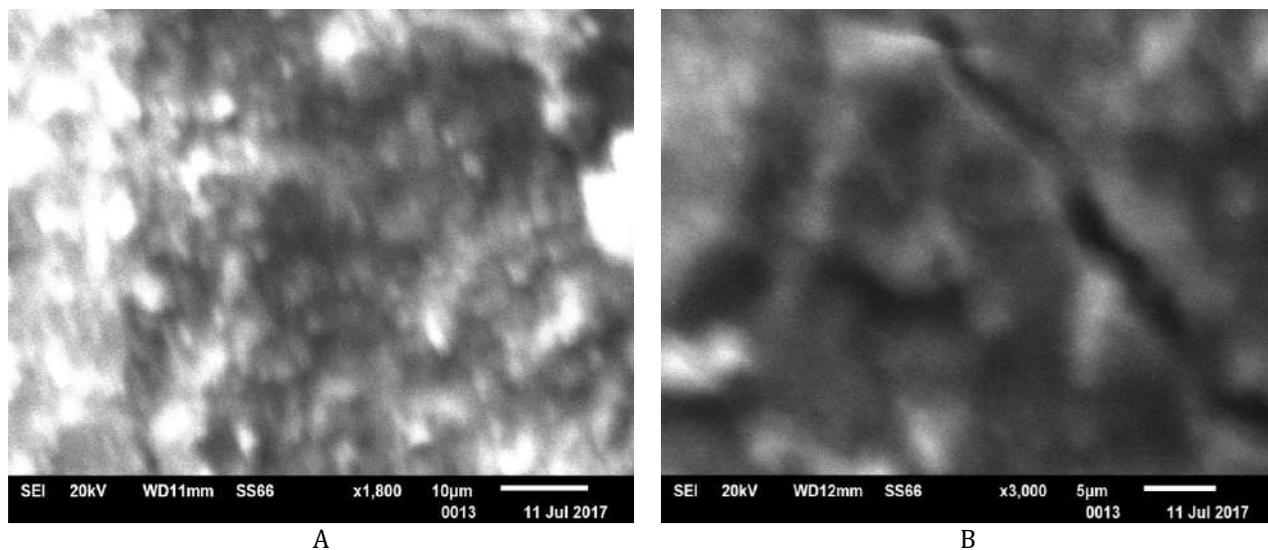
Fig. 4: SEM images of the membrane surface

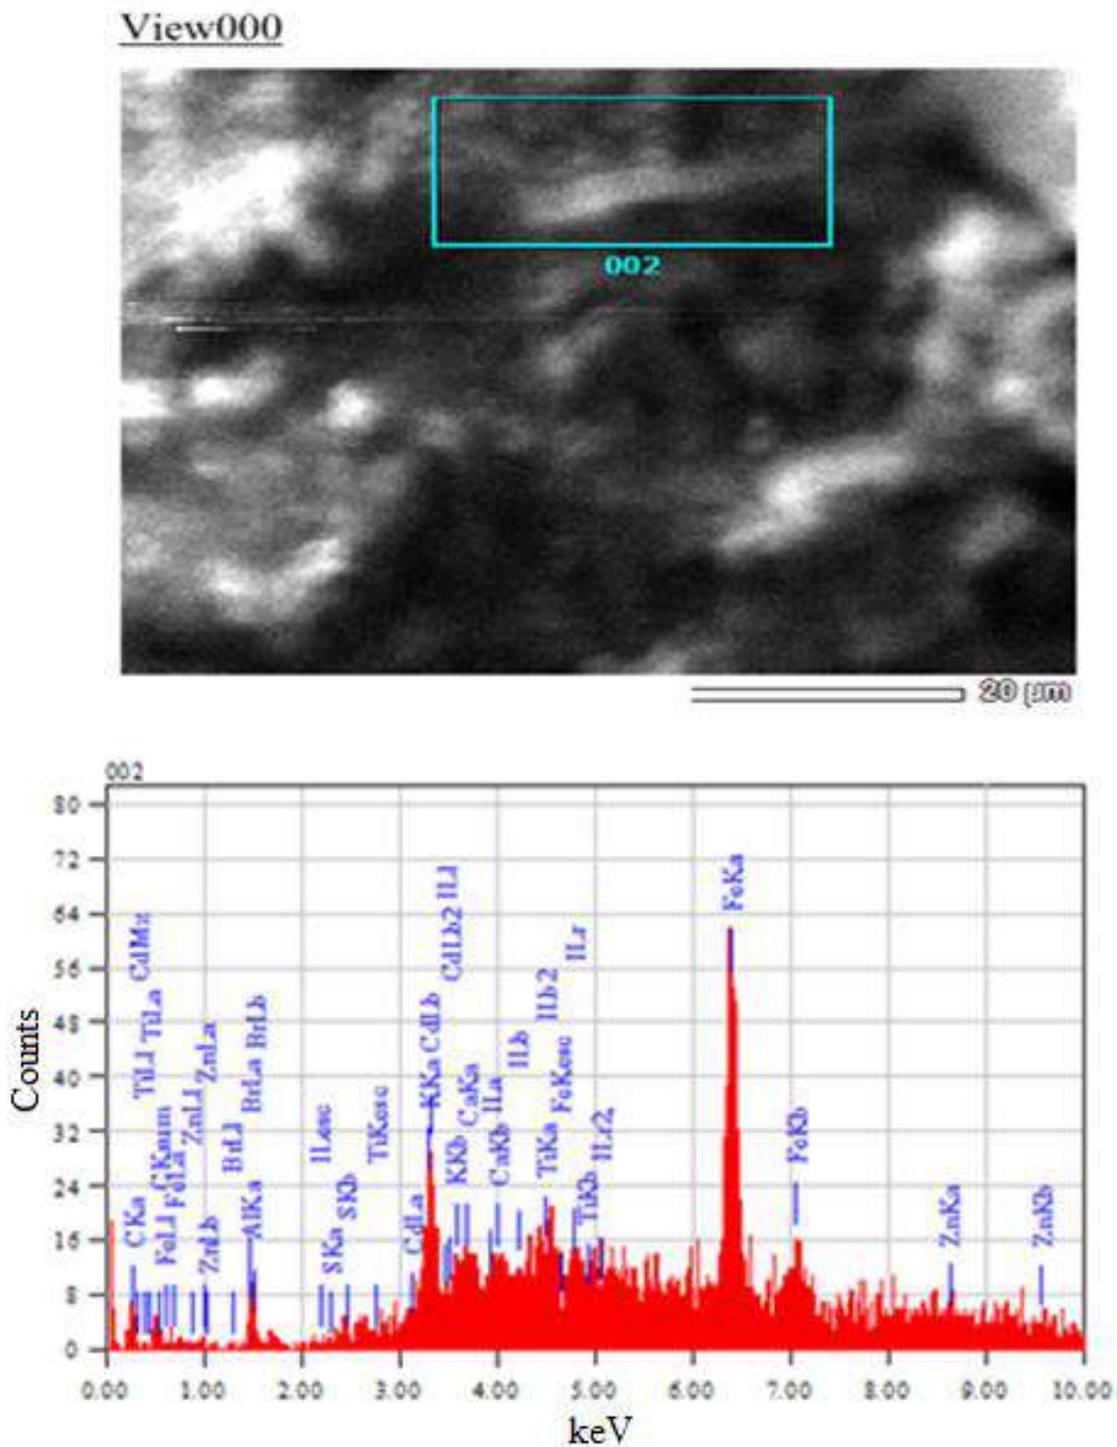
Fig. 5: SEM image and micrograph of the membrane surface – out of the feed spacer

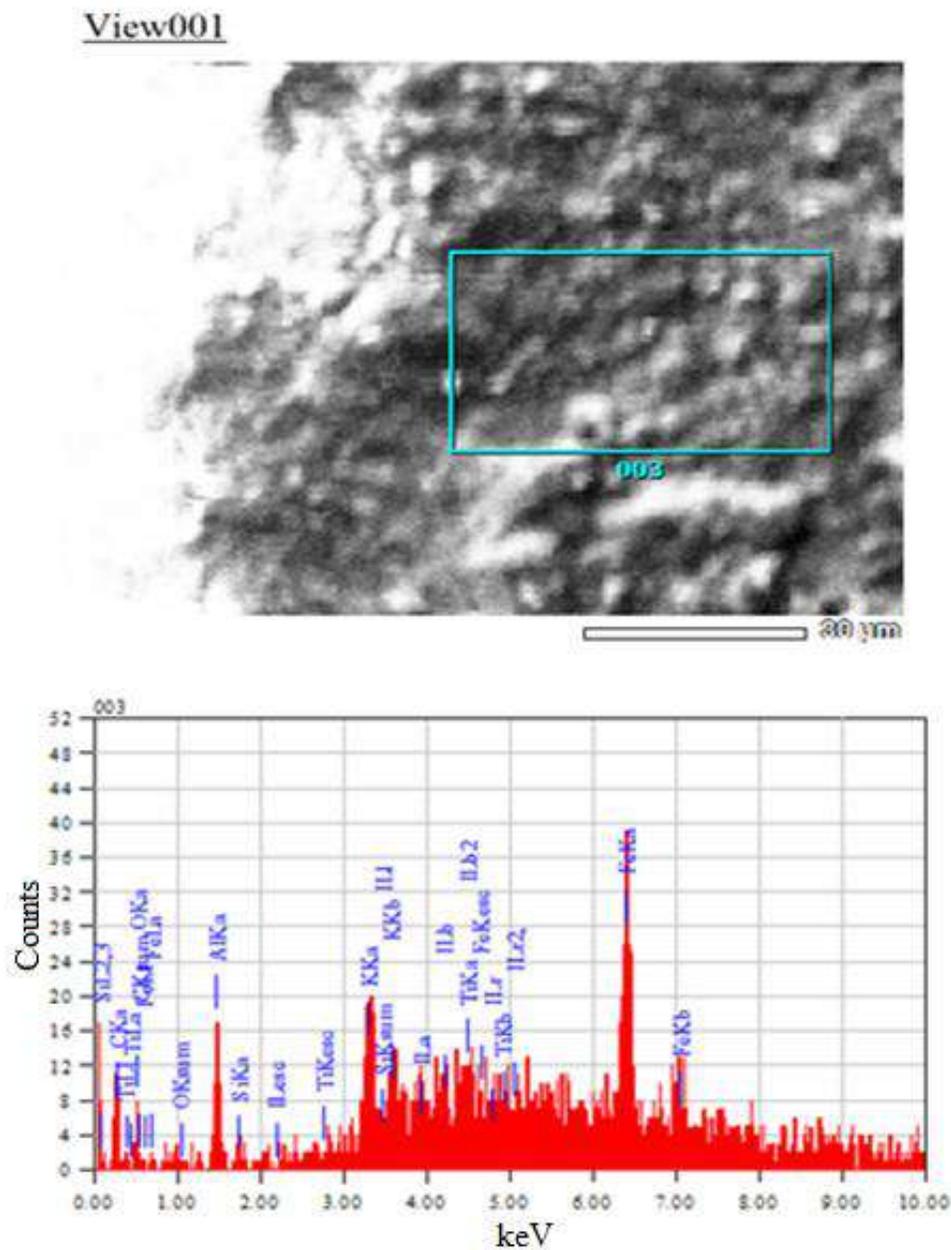
Fig. 6: SEM image and micrograph of the membrane surface – under the feed spacer

The C and O peaks are likely due in part to organic and/or biological materials. The high levels of Al and Si in the particulate matter suggest that it was mainly aluminium silicates which are common foulants in RO operations (Thuy et al., 2007). The use of iron chloride as coagulant prior to the RO treatment could also elevate the Fe concentration in the RO feed which can prove the presence of iron dioxide in the foulants.

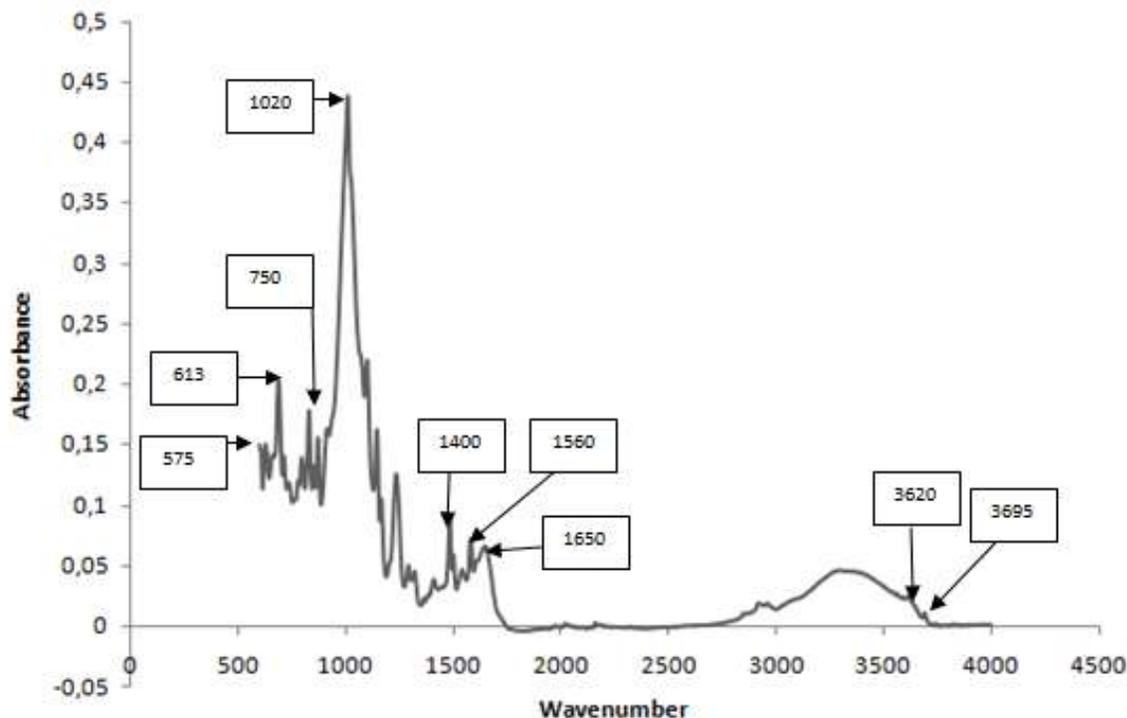
Figure 7 shows the FTIR spectrum obtained for the fouled membrane. A typical FTIR spectrum of the fouled membrane extract is shown in Fig. 7. The main absorption bands were in the vicinity of 1020 cm^{-1} (Si-O and Al-O) of silicate. In addition, the mass around 575 cm^{-1} suggests that the fouling is composed of amorphous structures of phosphates. The band in the vicinity of 613 cm^{-1} indicates the presence of iron sulfate, 600–800 cm^{-1} could be due to aromatic compounds, 1400 cm^{-1} could be due to aliphatic C-H deformation, C-O stretching and O-H deformation of phenol.

Fig. 7: FTIR spectrum of the fouled membrane extract

The bands in the range of 1500- 1650 cm^{-1} are due to (amide I and N-H deformation + C-N stretching of amide II, symmetric stretching of COO⁻). This band may indicate the presence of protein, 3620 cm^{-1} and 3695 cm^{-1} aluminum silicate.
